Recreational Boat Collision Accident Research

Volume 1

Miles A. Beam III, P.E.
Senior Project Engineer
Marine Department

Underwriters Laboratories Inc.

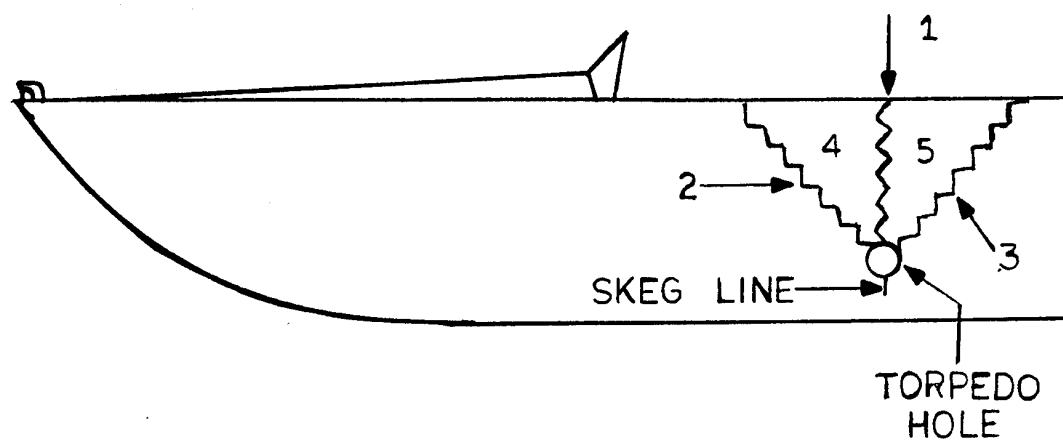
Figure 6-1

Typical Damage to Hull Side After Collision

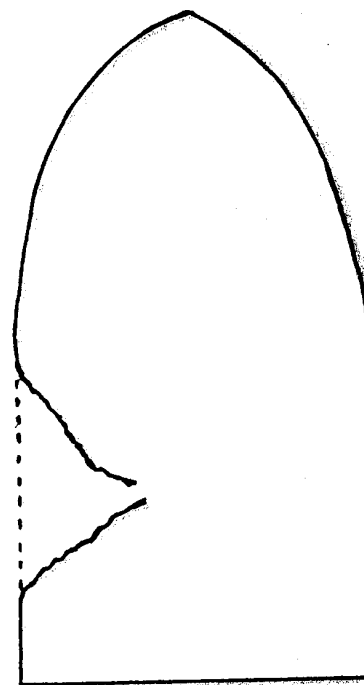
Damage to Boat After an Override Collision

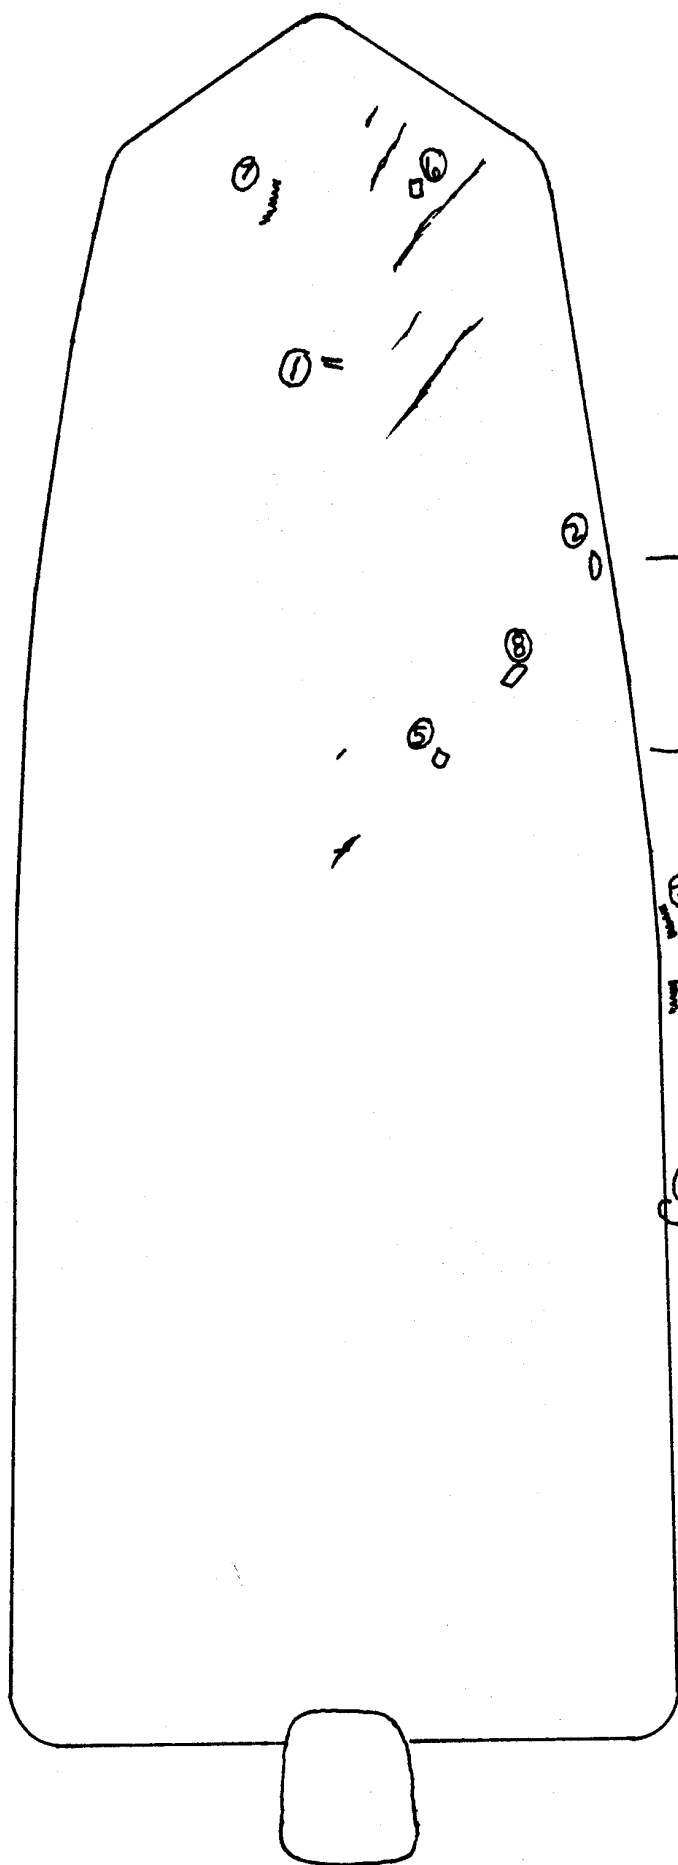
Bullet Boat Damage Diagram
Figure 13-3

- ① chip on bow
- ② cleat w/chips from other boat
- ③ Rub Rail marks on side
- ④ Small chip above Rub Rail
- ⑤ Large Chunk off Spray Rail
- ⑥ Chunk from outside spray Rail
- ⑦ Bottom damage
- ⑧ Chunk on last spray rail

Accident #1
Bullet Boat

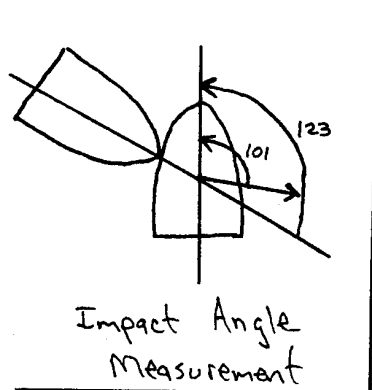
Figure 13-7

① Beginning of Contact
 damage on portside.

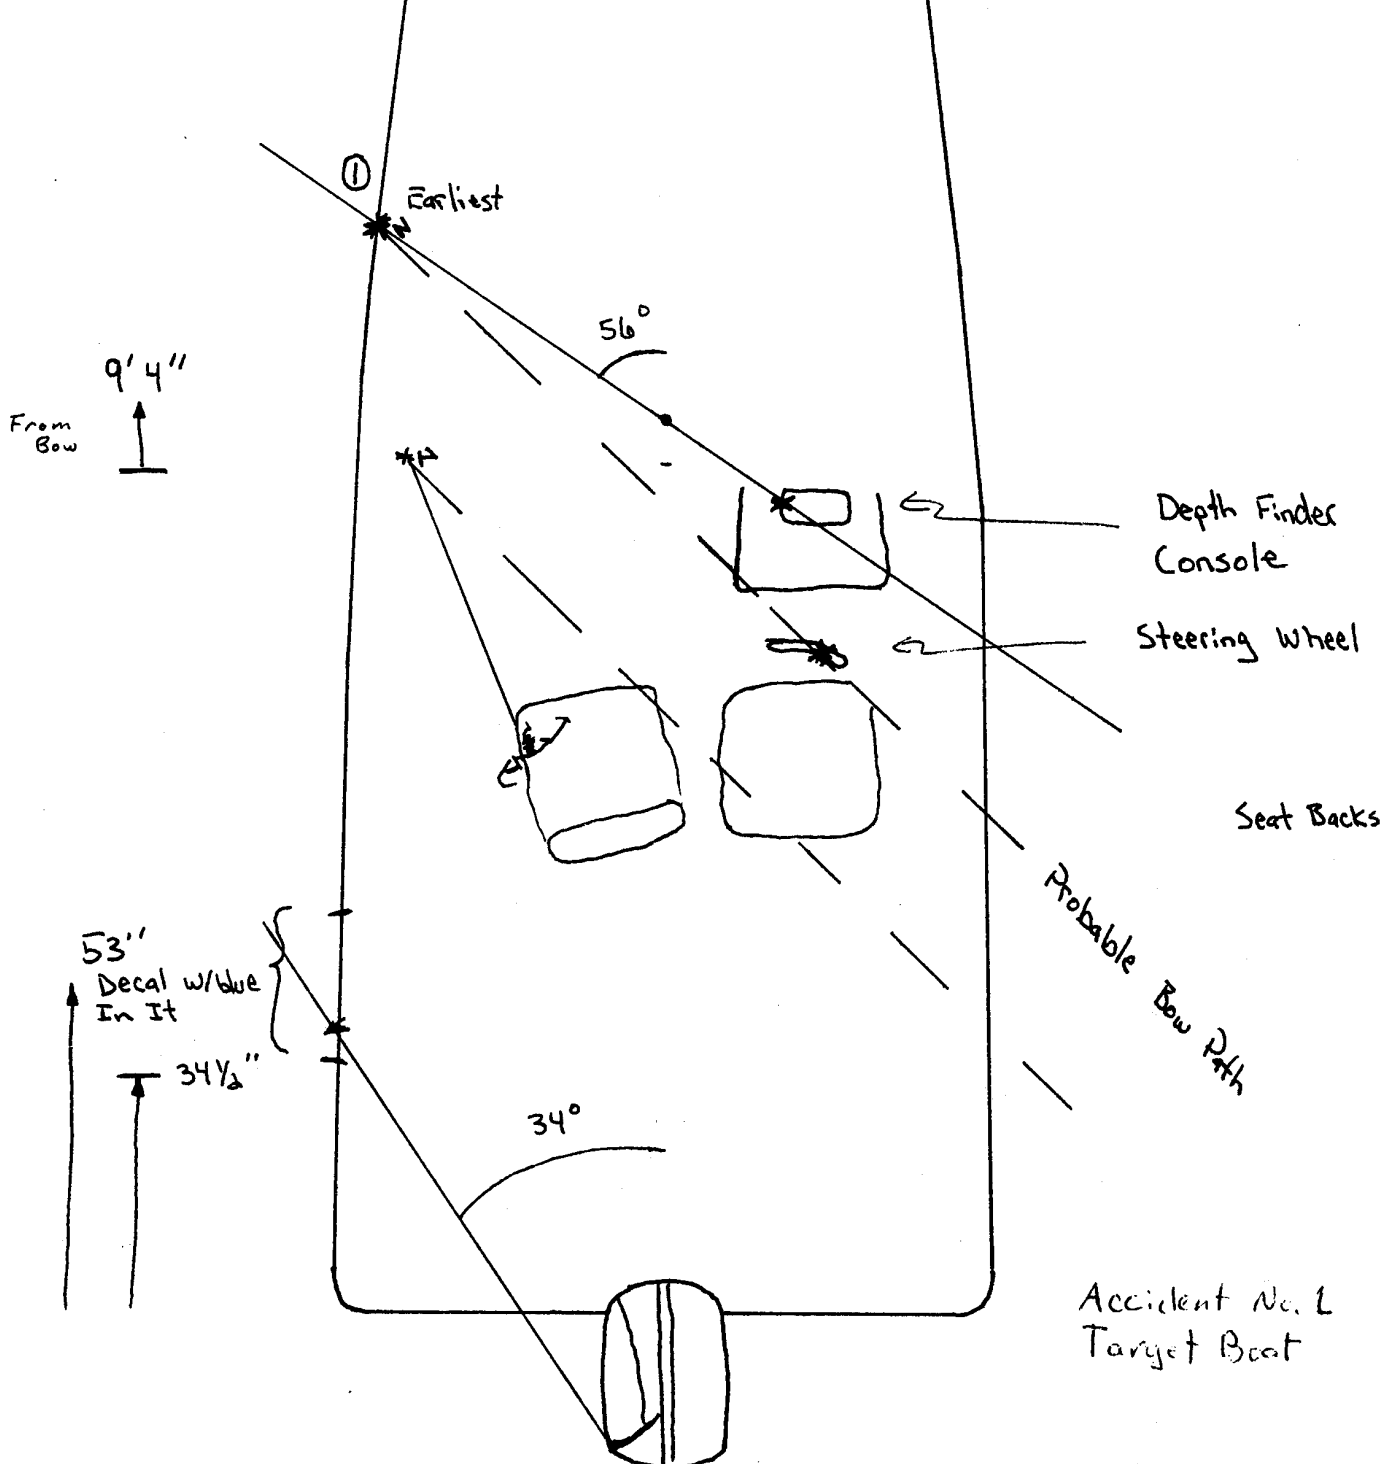
Accident No:1, Striation Analysis for $\theta_2 = 101$ degrees.

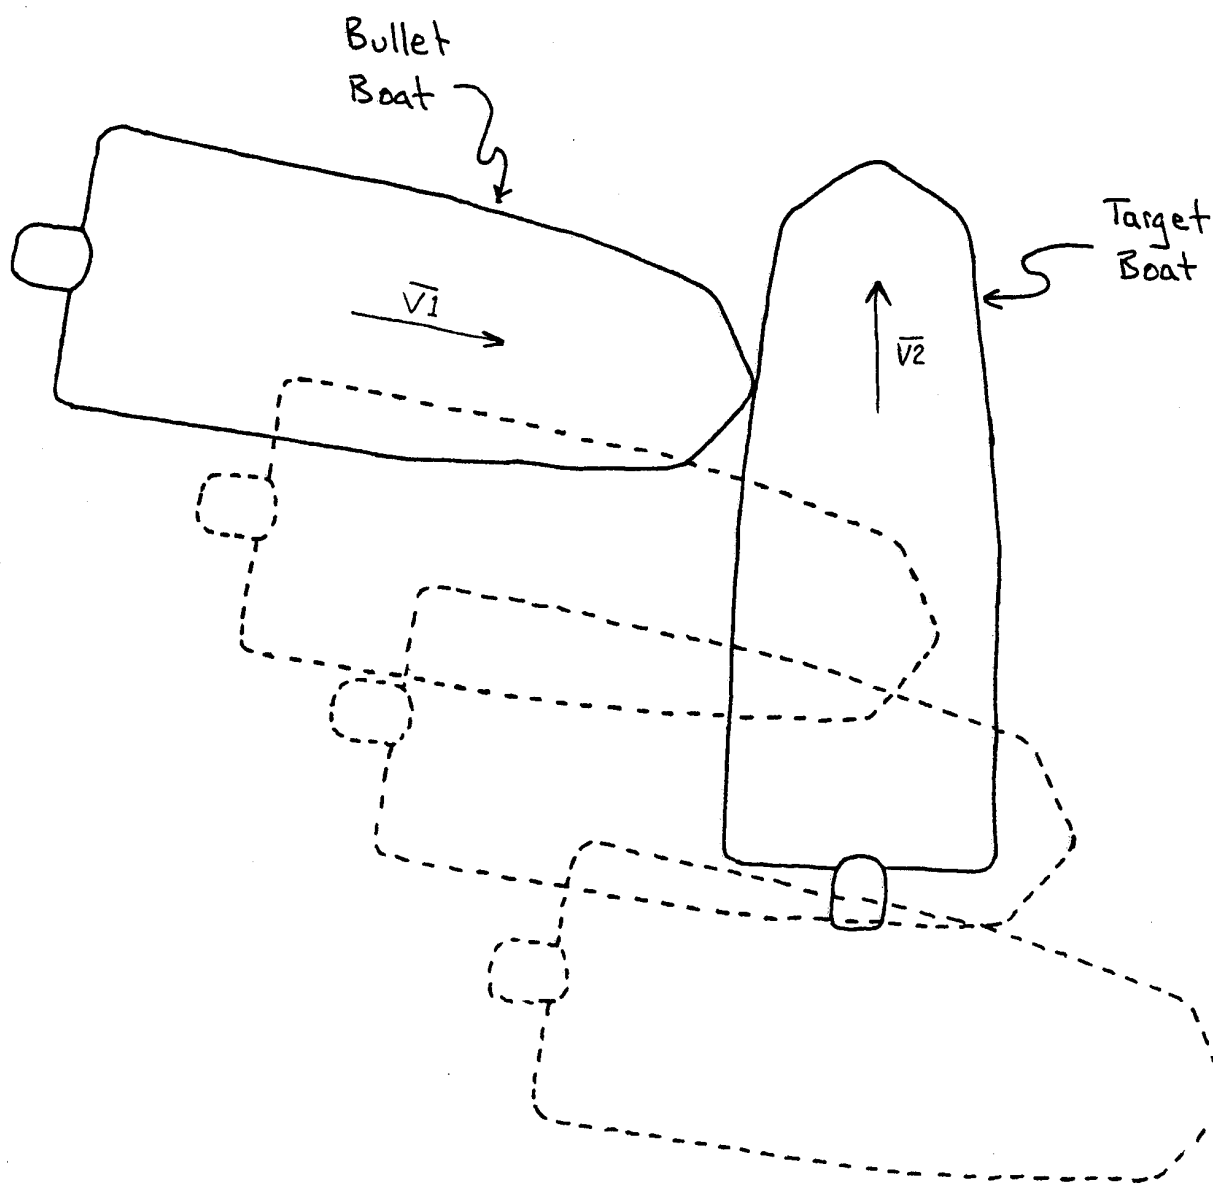
Figure 13-11

Approximate Path of the Bullet Boat Across the Target Boat.

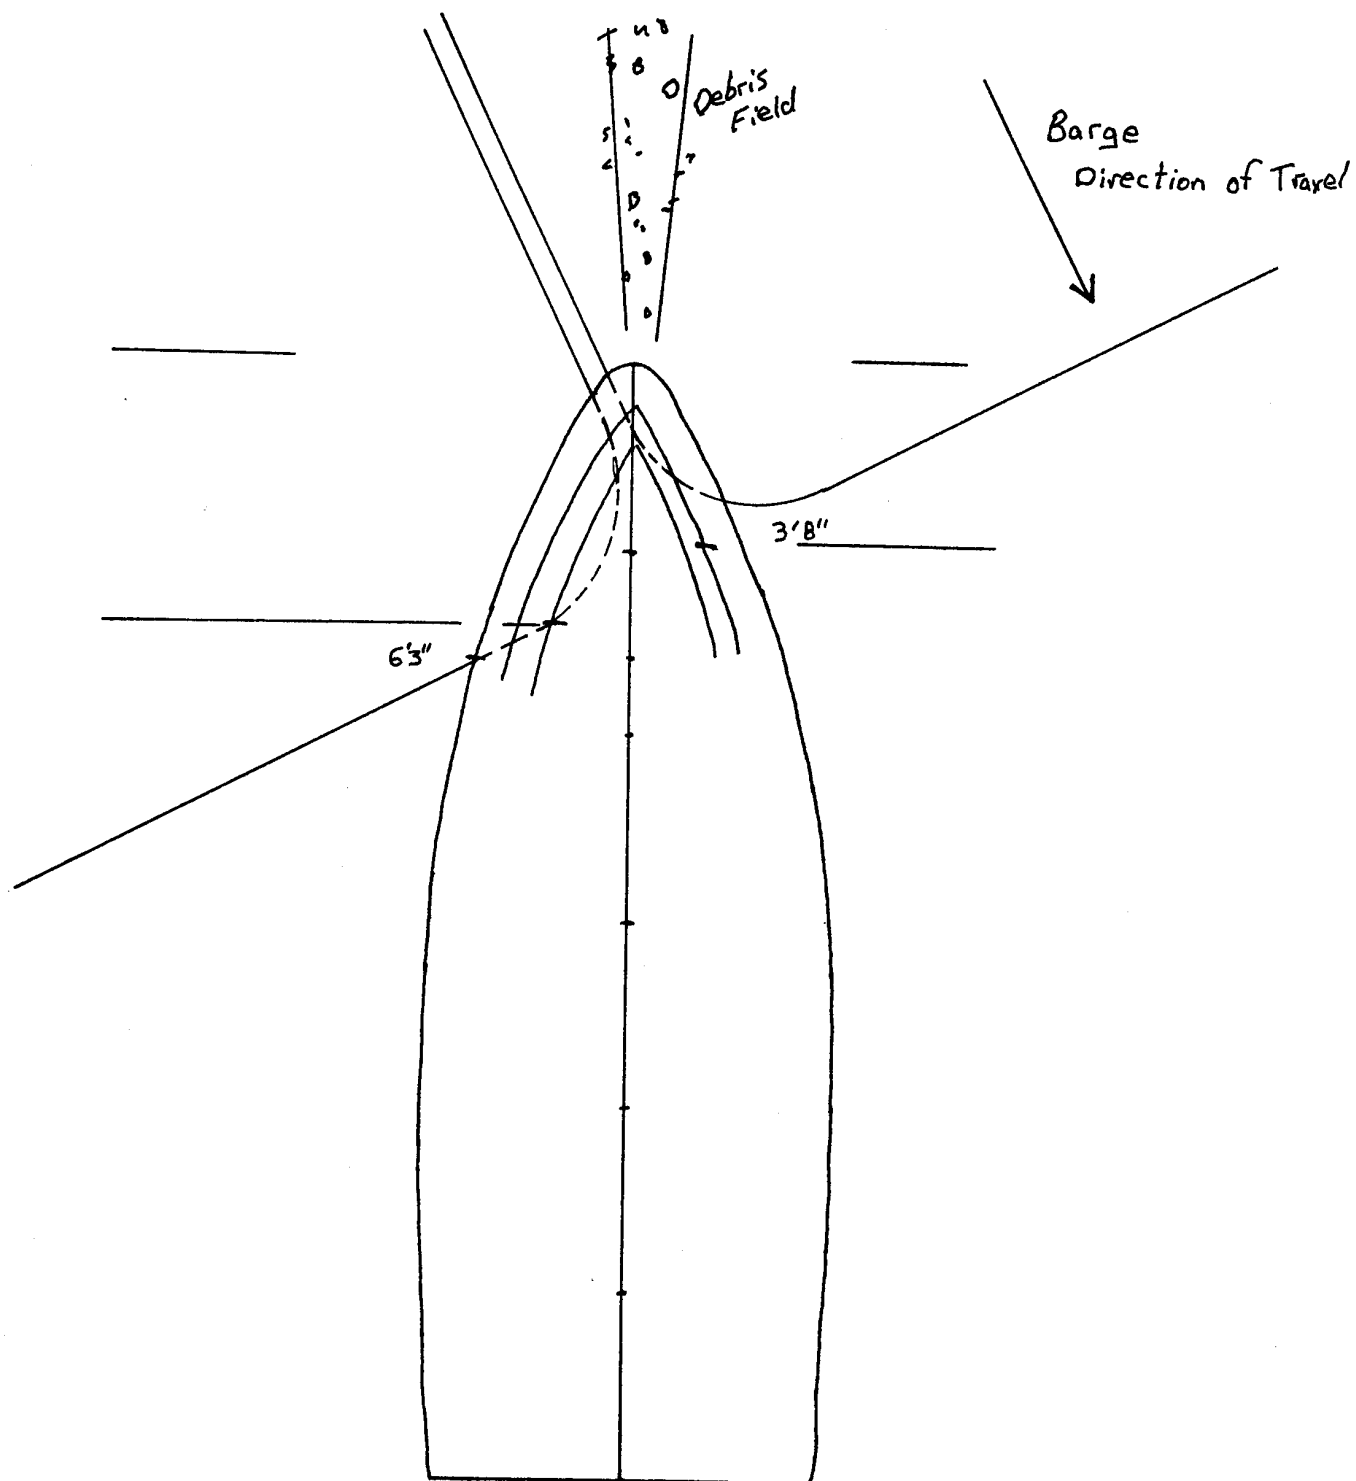
Figure 13-35

This Diagram Shows How Much of the Barge May Have Penetrated the Hull.

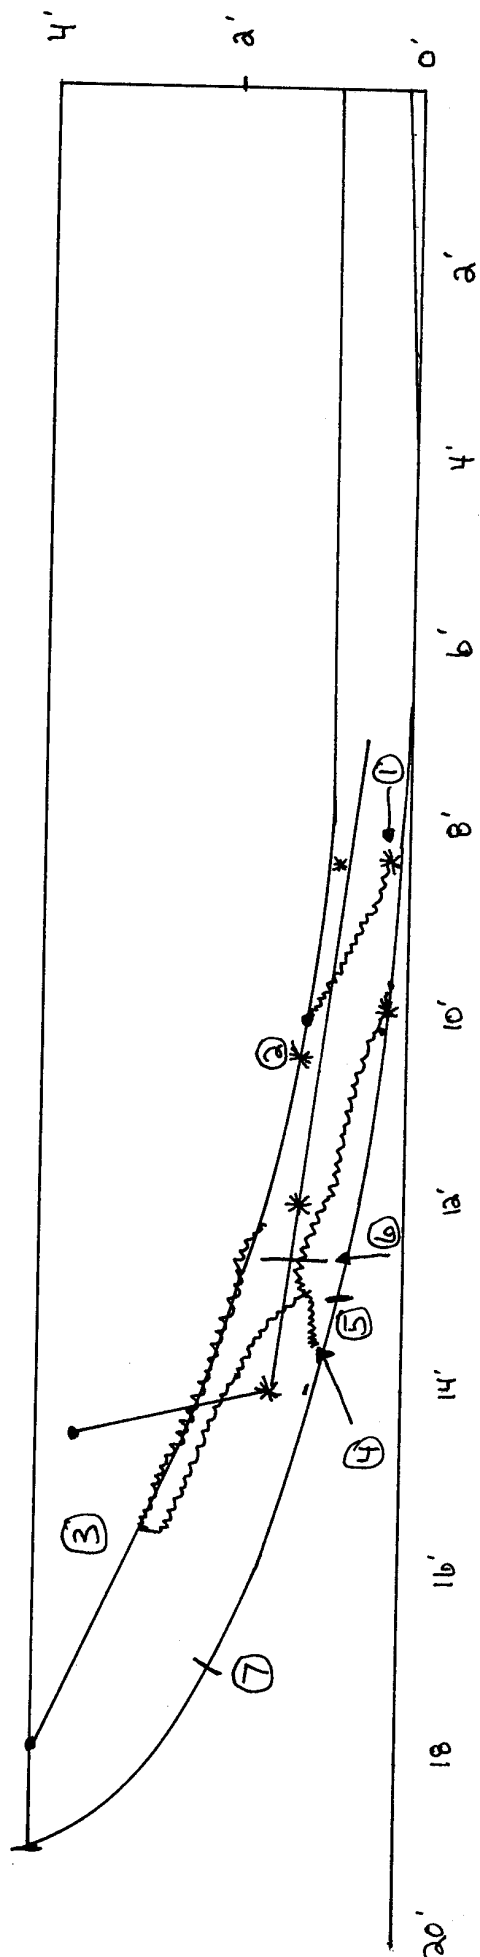
Figure 13-71

- ① end of "hole"
- ② hole at chime - aft
- ③ beginning of hole at chime - fwd
- ④ crack
- ⑤ main crack line
- ⑥ vertical cut
- ⑦ red paint transfer on rub rail
